DEPARTMENT OF TRANSPORTATION

Quality Assurance and Source Inspection

Contract #: 04-0120F4Cty: SF/ALA Rte: 80 PM: 13.2/13.9File #: 1.28**WELDING INSPECTION REPORT****Resident Engineer:** Casey, William**Address:** 333 Burma Road**City:** Oakland, CA 94607**Report No:** WIR-028090**Date Inspected:** 31-Jul-2012**Project Name:** SAS Superstructure**OSM Arrival Time:** 700**Prime Contractor:** American Bridge/Fluor Enterprises, a JV**OSM Departure Time:** 1930**Contractor:** American Bridge/Fluor Enterprises, a JV**Location:** Job site**CWI Name:** Julian Razo**CWI Present:** Yes No**Inspected CWI report:** Yes No N/A**Rod Oven in Use:** Yes No N/A**Electrode to specification:** Yes No N/A**Weld Procedures Followed:** Yes No N/A**Qualified Welders:** Yes No N/A**Verified Joint Fit-up:** Yes No N/A**Approved Drawings:** Yes No N/A**Approved WPS:** Yes No N/A**Delayed / Cancelled:** Yes No N/A**Bridge No:** 34-0006**Component:** OBG**Summary of Items Observed:**

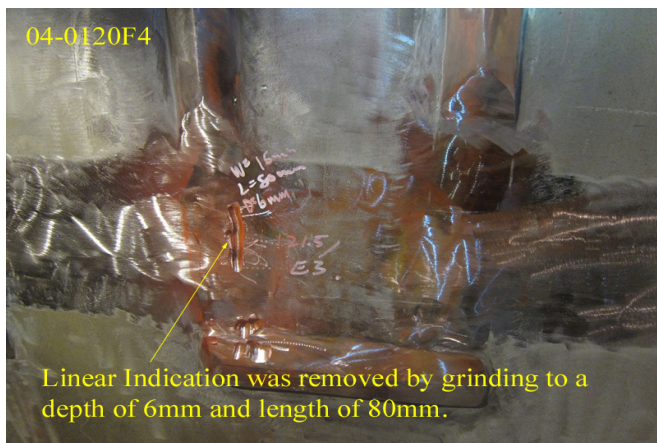
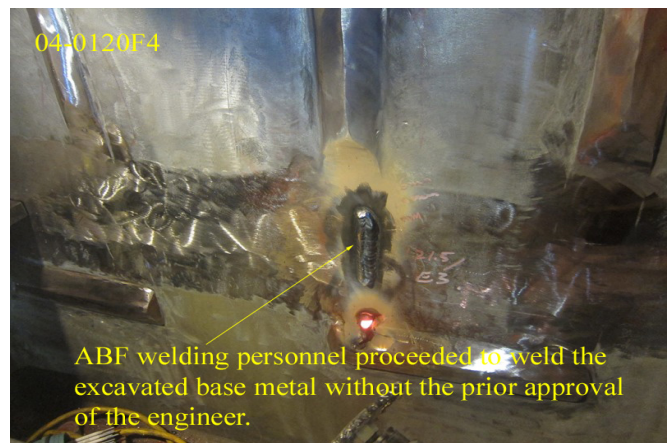
The QAI observed ABF QC inspector Salvador Merino perform Magnetic Particle Testing (MT) in way of the lifting lug removal areas on the longitudinal diaphragm web at E3, a 60mm linear indication was observed. After the removal of the indication by grinding, ABF welding personnel proceeded to weld the excavated base metal without the prior approval of the engineer. The final depth of the excavation in the web was measured to be 6mm. The lifting lug removal area is located at lift 13E, East of panel point 121.5. The longitudinal diaphragm web is designated as a Seismic Performance Critical Member (SPCM) on the contract drawings and requires through thickness properties (TTP). The QAI's observations were discussed with the QA lead inspector Danny Reyes.

The QA inspector periodically observed ABF/JV qualified welder Lin Yun #9344 performing Shielded Metal Arc Welding (SMAW) in the 2F position utilizing the Caltrans approved Welding Procedure Specification ABF-WPS-D1.5-F1200A. The welding observed was for the longitudinal diaphragm stiffener fillet weld connection. The weld surface and surrounding area was brought to temperature by the use of a gas torch and the preheat temperature was confirmed ABF personnel prior to welding.

K-plate to longitudinal deck stiffener connection at panel point 120.5. A total of two (2) rejectable indications were observed to be marked for repair at the time of inspection.

The QA inspector periodically observed, ABF/JV qualified welder Xiao Hua Luo # 1291 performing Shielded Metal Arc Welding (SMAW) in the 4G position utilizing the Caltrans approved Welding Procedure Specification ABF-WPS-D1.5-1162-4. The welding observed was for the HPS-485 longitudinal stiffener wing plate attachment welds located between panel points 124.5 and 125 at LS2. The weld is a Partial Penetration Tee joint. The weld surface and surrounding area was brought to temperature by the use of induction heaters and the preheat temperature was confirmed ABF personnel prior to welding.

The QA inspector noted and periodically observed ABF/JV qualified welder Rick Clayborn #2773 performing Carbon Arc Gouging (CAG) in the overhead position for the repair of the deck drop-in splice between panel point 122~122.5 designated as 13W-W2.1. The weld surface and surrounding area was brought to temperature by the use of induction heaters prior to gouging. The weld will be re-gouged 100% due to the amount of indications found during the ABF QC final Ultrasonic Testing inspection. The repairs at this location are being conducted in accordance with RWR-201207-016.
